# A case of sheared epidural catheter: where is the piece of plastic?

# Management of a Sheared Epidural Catheter<sup>1</sup>

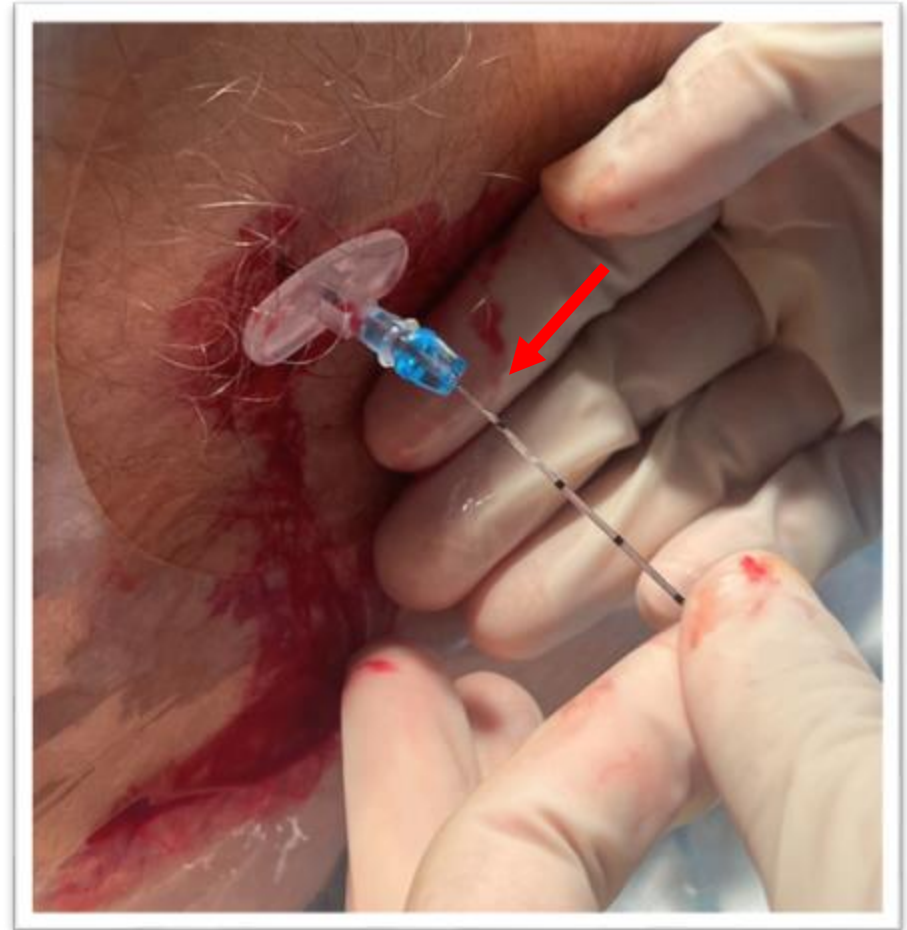
- During labor epidural placement, LOR obtained at 8cm
- Catheter advancement paused until LLE paresthesia resolved
- During catheter readvancement, unable to thread catheter past 15cm
- **Gentle backwards traction applied on catheter; catheter fracture noted** (Image 1)
- Needle and catheter removed as whole unit
- Although entire wire intact, distal 5cm plastic portion of catheter sheared off, concerning for retained plastic catheter fragment

**Image 1:** Sheared epidural catheter  
(photo used with patient permission)

1. **DO NOT** pull backward traction on epidural catheter while still within the needle
2. Remove the catheter and needle as a **whole unit**
3. Do not thread catheter more than **4–5 cm** in the epidural space to prevent coiling, knotting, entrapment of catheter
